2 Year Follow-up on Full Thickness, non-retracted Rotator Cuff Tear Treated with Stem Cells

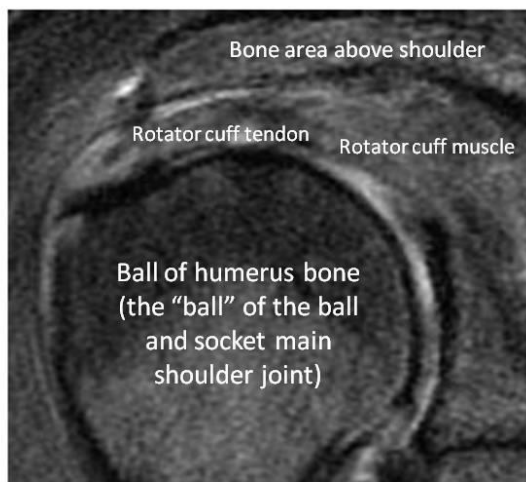
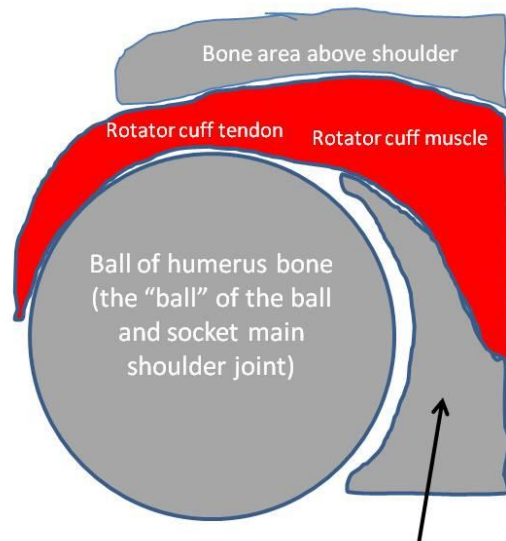
2.04.2008 COR MRI

COR MRI. ET=7, TR=2350, TE=62.2

Acetabulum or shoulder joint socket

The image above is this patient's pre-injection coronal MRI. A coronal MRI slice is one that lets you look from the front or the back. Here you can see the MRI on the left and the diagram of the MRI to the right. The rotator cuff tendon is the area of interest. The rotator cuff like any muscle has two parts, the muscle belly and the part that attaches the muscle to the bone, the muscle tendon. Rotator cuff tears commonly occur at the muscle tendon area. In addition, MRI images

come in many different flavors, some show water as bright or a lighter color, which is what's being shown here in these PDFS sequences. So on this image, a darker appearing tendon is good, one with light spots in it is bad. A normal rotator cuff tendon in this type of MRI sequence would be a uniform darker color or black (depending on age).

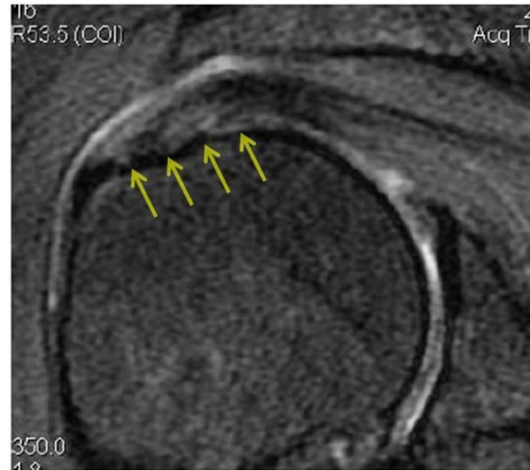
6.24.2010 COR MRI

COR MRI. ET=7, TR=2350, TE= 62

Now for the patient MRI's. Above on the left is an MRI taken 2 months before her stem cell injection in April 2008, the image on the right is her 2 year follow-up MRI. The left MRI shows the rotator cuff tendon (red arrows) which is bright in color and mottled in appearance. This means that it's a full thickness rotator cuff tendon tear with severe degeneration (she's 78 years old at the time of this picture). To the right is her two year follow-up MRI showing a darker appearing rotator cuff tendon (yellow arrows) without any light color that goes all the way through the tendon (she's 80 years old in this picture). Clearly an improvement that's still holding and demonstrated not only by her reports of no pain and full function, but also objective MRI imaging two years later.
